Site Inspection, Molycorp, Small Fry Mine, M/037/022, San Juan

County, Utah

Date of Inspection:

May 11, 2004

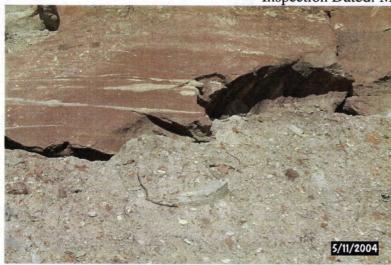
We believe there were about four openings into the side of the hill, but only about two of these were adits going in to the mine. These openings were backfilled but not sealed with block walls. It appears the material that was backfilled against the highwall has been settling, and the top has pulled away from the rock (Photo 1). I looked in to this crack between the rock and backfill material but could see no farther than about a foot. I am not certain whether these cracks extend into the mine or office or shop facilities.

Photo 1. Fill is pulling away from the areas of the backfilled portals.

We definitely need to watch the portal area and see whether the cracks open any more, particularly if they open into the mine. If this happens, remedial action will be necessary.

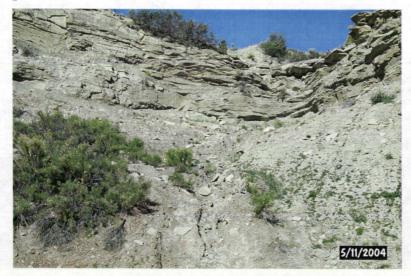
On the edge of the plateau above the south part of the mine, there is an area where a berm was built (Photo 4) in an apparent attempt to keep runoff from eroding a portion of the slope above the mine (Photo 2). The berm has been breached (Photo 3), possibly intentionally, and a small gully has formed leading to the mine site. Although one can see where runoff crosses the pad and continues down the hill, this erosion is not too serious.

Photo 2. Erosion in a drainage on the south end of the site.

I'm not terribly concerned about the gully coming down from the top of the plateau to the south part of the mine site. It looks like it's been there for several years and has caused little damage.

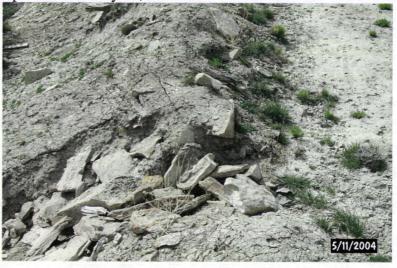
Photo 3. Breach in the berm at the top of the gully in Photo 2.

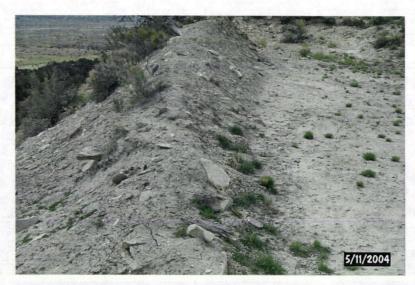
Photo 4. Berm at the top of the slope in Photo 2.

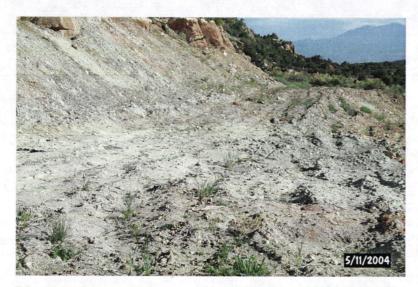
At the main mine site, revegetation success is spotty with a lot of plants in some places and very few in others (Photo 5). Areas where shale is on the surface have had the poorest success so far. We found hundreds of rabbitbrush seedlings which, if they can become established and continue to grow, will provide a lot of cover in a few years. We also found a fair amount of fourwing saltbush and blue flax along with the grasses. It is still not easy to tell some of the annual grain plants from the perennial grasses.

Photo 5. Revegetation on the pad in front of the portals.

I believe the vegetation will continue to progress, and it is likely it will meet release criteria after the 2005 growing season. This will, of course, depend to a large degree on the weather, but if the rabbitbrush seedlings can become established, they should boost the vegetation cover values.

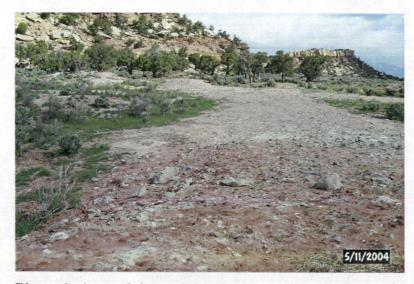
In the area of the vent shaft, much of the material on the surface appears to have come from the shaft, and it includes a gray shale. A few plants have become established in this area, but not a lot (Photo 6).

Photo 6. Area of the reclaimed vent shaft on top of the plateau.

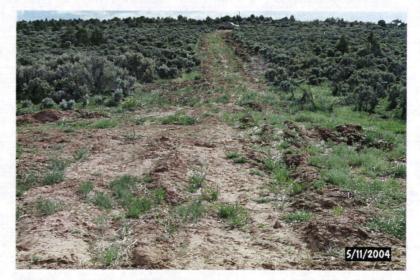
Vegetation is coming along very well on the road to the vent shaft (Photo 7) and in the areas on top of the plateau where power lines were removed. There was not a lot of disturbance in these areas, so the native soils are still present.

Photo 7. The road leading to the vent shaft shown in Photo 6. The soil seems to have made a vast difference in the amount of reestablished vegetation.
